**THE PLACE DAM  
WASHINGTON COUNTY, MISSOURI  
MO 30996**

**PHASE 1 INSPECTION REPORT  
NATIONAL DAM SAFETY INSPECTION**

**DECEMBER 1980**

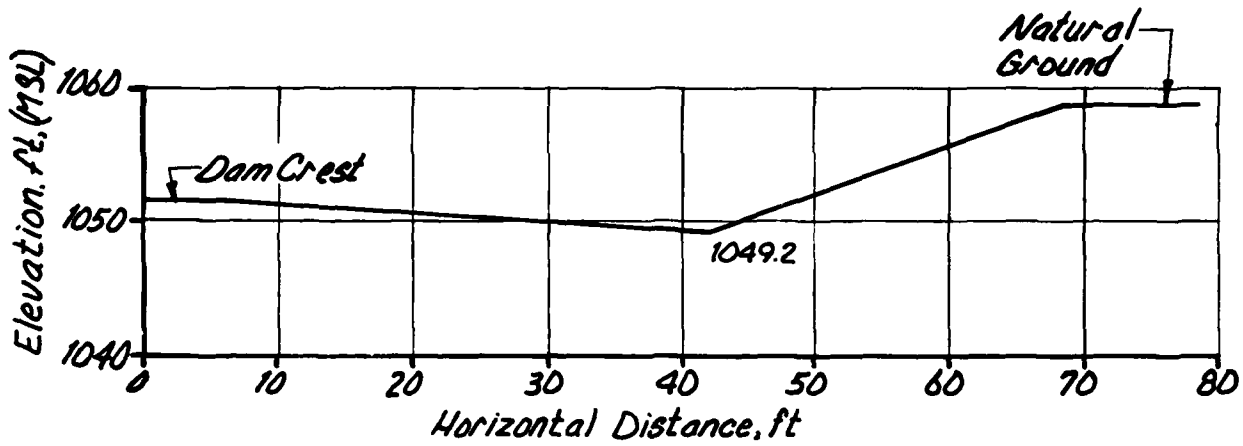
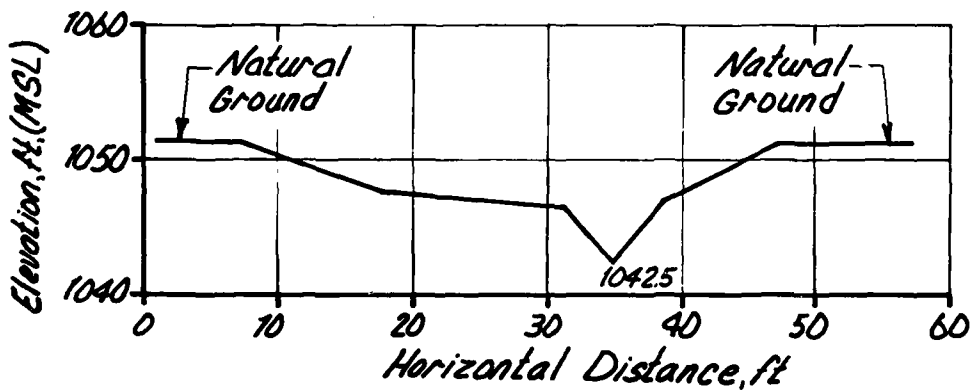
FIG. 3B

2. Auxiliary spillway. The auxiliary spillway is located at the right abutment. It is also unlined, uncontrolled and roughly "V" notch in shape (Photo 4). The gravelly clay soil is considered to be moderately erodible. Sparse weedy growth covers most of the surface. Erosion of the spillway does not appear to pose a safety hazard to the dam.
